# Phase I Environmental Site Assessment Report

MDI Hospital
10 Wayman Lane
Bar Harbor, Maine 04609

January 16, 2025
Project # BE-849

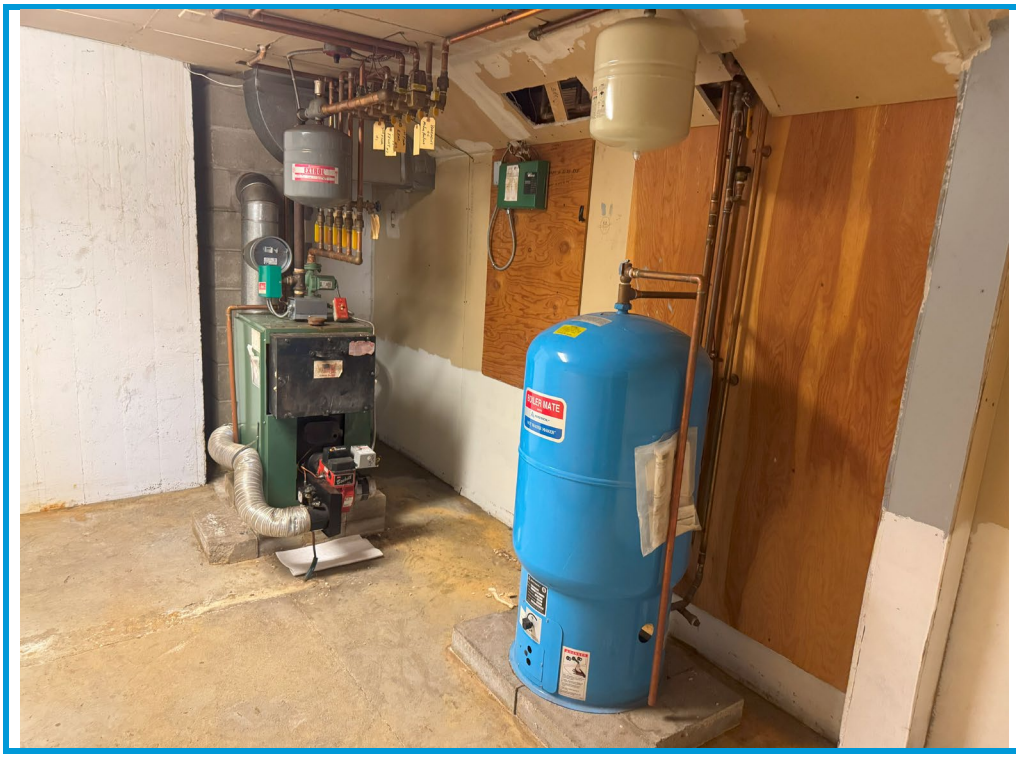
**Photo No.** 60

**Description:**
Heating oil AST in the basement of 9 Hancock Street.
